Emission Reduction with ESP Upgrade at Coal-Fired Power Plant

4 units ESP for Coal-Fired Power Boiler Plant in Indonesia

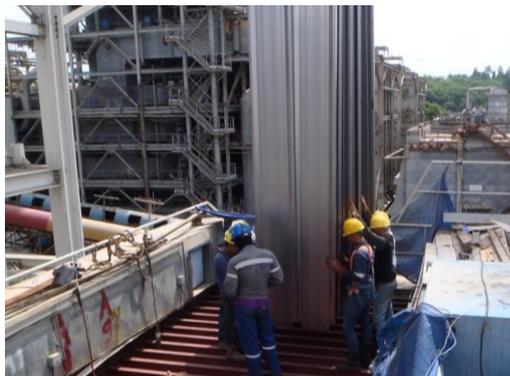
Collecting Plate Installation

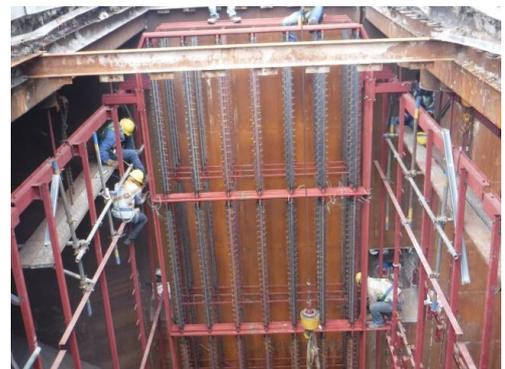
Installing DE Frames

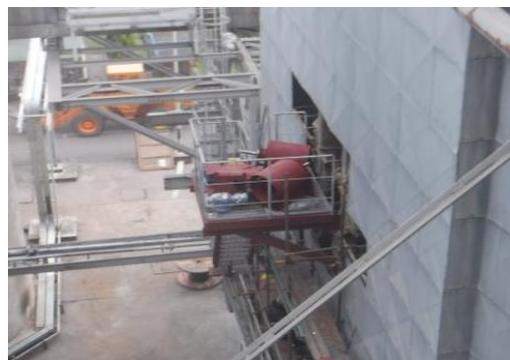
Installing New Platform and additional CE &
DE Rapping Motors

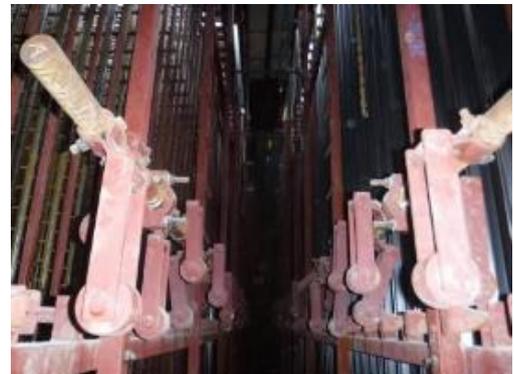
DE Rapping System Installation

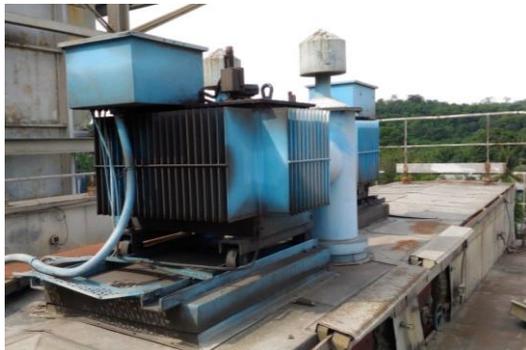
Conventional Transformer Rectifier
(T/R set) Before Retrofit

1. Discharge Electrode (DE) is replaced from the original saw-band type to rigid discharge electrode type (RDE).
2. Conventional T/R set was upgraded by high frequency T/R set (HFTR) or called Switch Mode Power Supply (SMPS).

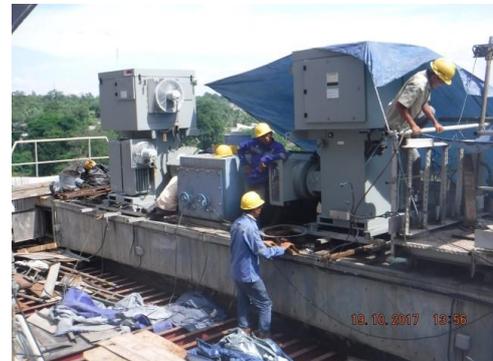
SMPS Installation
