Metalized Film Capacitors Keep Pace With High-Voltage IGBT Modules

Ralph M. Kerrigan, NWL, Snow Hill, North Carolina

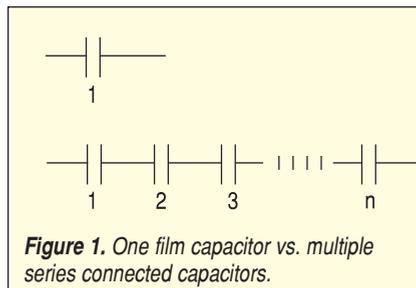
Figure 1. One film capacitor vs. multiple series connected capacitors.

- 1) The energy density increase of film capacitors has greatly reduced their size.
- 2) The reduction in film capacitor size has greatly reduced their cost.
- 3) The newer semiconductors now allow fewer series voltage levels in some applications. In these applications a single film capacitor replaces several series connected aluminum electrolytics (*Figure 1*).
- 4) A single film capacitor with a ripple current rating of 300 to 600A can replace 10 to 30 of the series wired groups in parallel (*Figure 2*).

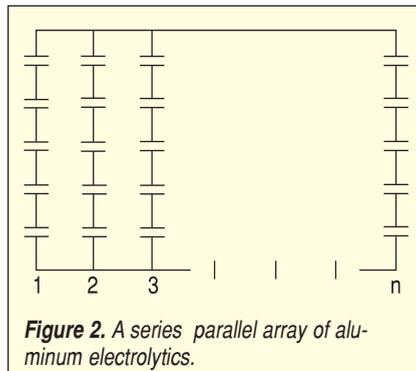
Figure 2. A series parallel array of aluminum electrolytics.

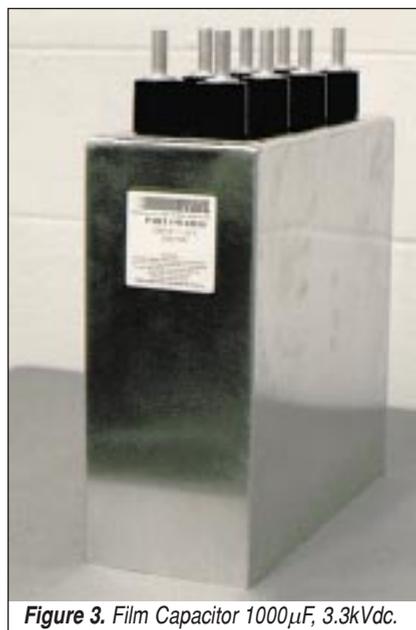
Figure 3. Film Capacitor 1000 μ F, 3.3kVdc.

The new type WA film capacitor is a selfprotected metallized polypropylene type in a welded aluminum case, which allows operation in magnetic fields generated by higher frequency operation. Often, stainless steel is substituted and serves a similar purpose. Terminal arrangements are made on the top of the capacitor to allow the parallel connection of several internal capacitor elements and a reduction in the series inductance. *Figure 3* shows a 1000 μ F, 3.3kVdc capacitor with eight terminals. This capacitor has a base of 34.3 cm x 15.0 cm and is 38 cm high. *Figure 4* illustrates the capacitor's configuration with four individual capacitors.

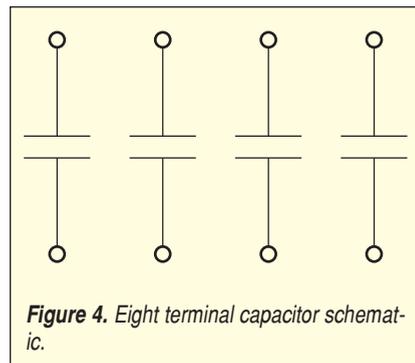
Figure 4. Eight terminal capacitor schematic.

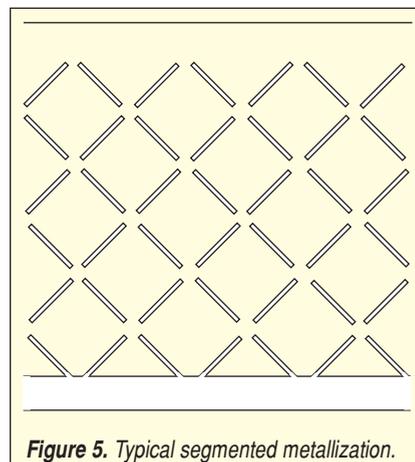
Figure 5. Typical segmented metallization.

In this 3.3kVdc capacitor, metallization consists of individual segments connected by narrow current gates (*Figure 5*). If one of the segments breaks down, the gates serve as fuses. Therefore, the damage to the capacitor is localized and the capacitance decreases only slightly while protecting the capacitor against complete destruction^[11]. *Figure 6* shows two gates of a segmented electrode that were closed by the energy from a selfhealing event.

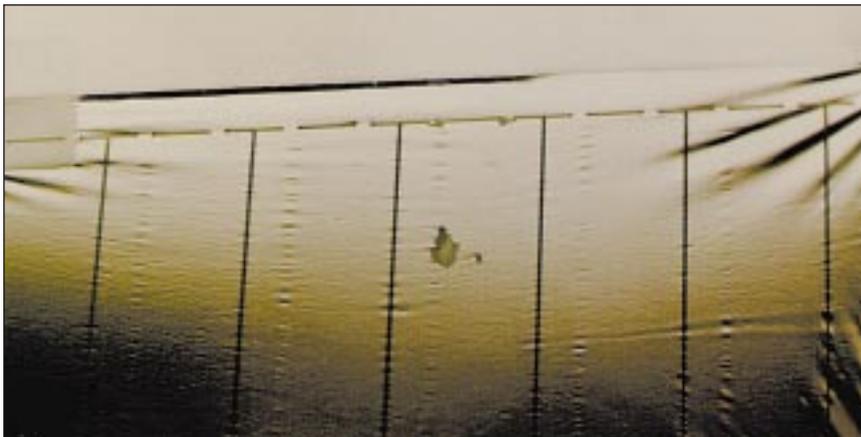
Figure 6. Operation of segmented electrode. (a). Dielectric puncture is in foreground (b). Two closed segmented fuses above.

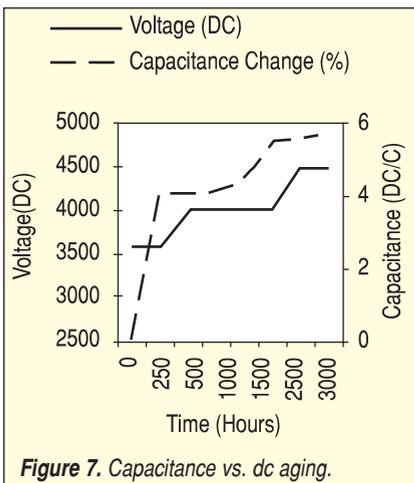
Figure 7. Capacitance vs. dc aging.

It was determined that only the capacitance value increased over the 3000hour period, as shown in *Figure 7*. This capacitance increase occurred at the start of testing due to electrostatic compression of the capacitor layers^[3]. This corresponds to a decrease in the gaps between adjacent electrodes in the wound capacitor elements that would normally increase the capacitance. What was of interest is not only did it occur at the start of testing, yet additional increases occurred after the voltage was stepped up further from 3.5kV to 4.0kV and again as the voltage was stepped from 4.0kV to 4.5kV after 2000 hours of testing. The dissipation factor during the testing was also monitored and although it went up about 20% during intermediate test intervals, it had dropped to its original value at the end of 3000 hours. Therefore little aging was observed after 3000 hours at substantially accelerated conditions on the 3.3kV design, including the final 1000 hours testing at 36% over nominal voltage.

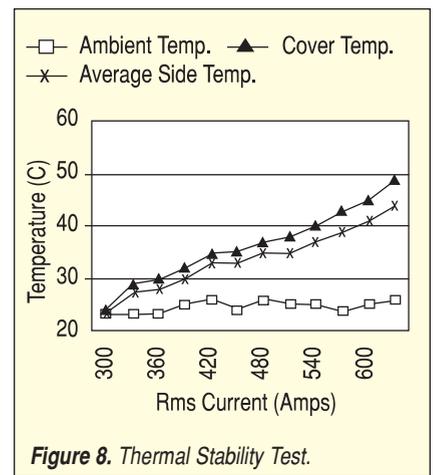
Figure 8. Thermal Stability Test.

The current steps and their temperature measurements for the thermal stability test are in *Figure 8*. After the completion of the 600A step, the ripple current was increased to 630A for an additional nine hours and the temperature measurements were

made at the end of this period. The theoretical current rating for the sample of 600Arms was based on an ambient temperature of 55°C and a permitted maximum temperature rise of 20°C.

It was desirable that the hot spot be below 80°C with a 5°C safety margin. At 25° ambient and 600Arms, the highest temperature was 45°C on the capacitor cover near the terminals. The cover would normally be expected to have a higher temperature because that is where the inner connections carry the heat. At 630Arms it can be seen that the selfheating has started to accelerate.

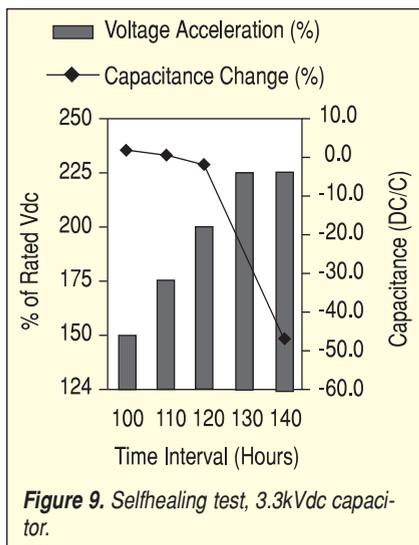
The accelerated aging evaluation clearly demonstrated capabilities up to 136% of rated voltage at 85°C. The test of the selfprotection feature was therefore started at 150% of rated voltage and stepped in increments of 25% of rated voltage. During this testing, pressure switches designed to open at 10 \pm 1 psi were installed in the capacitors in series with the voltage source. The step at 150% of rated voltage was for 100 hours and subsequent steps at 175% and 200% of the rated voltage were for 10 hours per step. The final step at 225% of the rated voltage was run until the capacitances were reduced to approximately 50% of their original measured values. The capacitance variation during this test is shown in *Figure 9*.

The selfprotection feature of the design was clearly demonstrated, although some capacitance reduction was observed at 175% of the rated voltage, substantial degradation did not start until 200% of the rated voltage. The capacitance loss accelerated

at 225% of the rated voltage. After eight hours at this step, the loss was about 25% on all samples. At 12 hours it was close to 40%, and at 16 hours it was close to a 50% reduction. After the 50% reduction in capacitance a bulge of 0.25 cm was detected in the sides of both samples, although this was not enough to activate either pressure switch.
